TECHNICAL MEMO

Project Name: City of Bishop – Chamber of Commerce Building Structural Condition Assessment

Subject: Chamber of Commerce Building Structural Observations and Recommendations

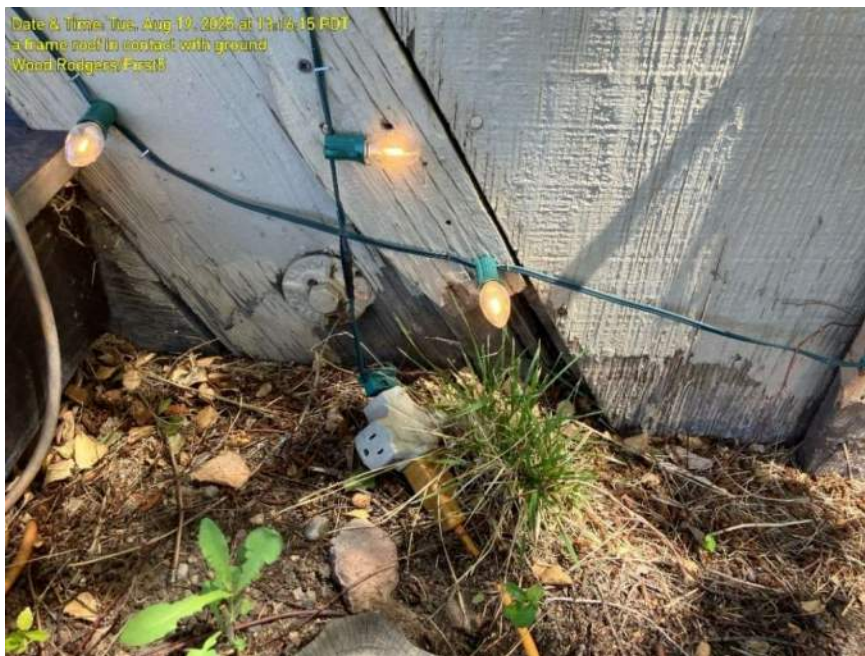
- At some locations of the roof, the framing was in contact with earth (refer to **Photo 1**). The roof rafter shows signs of dry rot. It also appears the bolted connection to the floor joist has been modified or was not built per the original drawings. This framing condition is considered POOR.

Photo 1 – Southeast corner of roof in contact with earth

- There are conditions where the existing roof framing is in contact with soil. The grading around the building needs to be modified so there is a minimum of eight inches of clearance between the roof and finished grade.

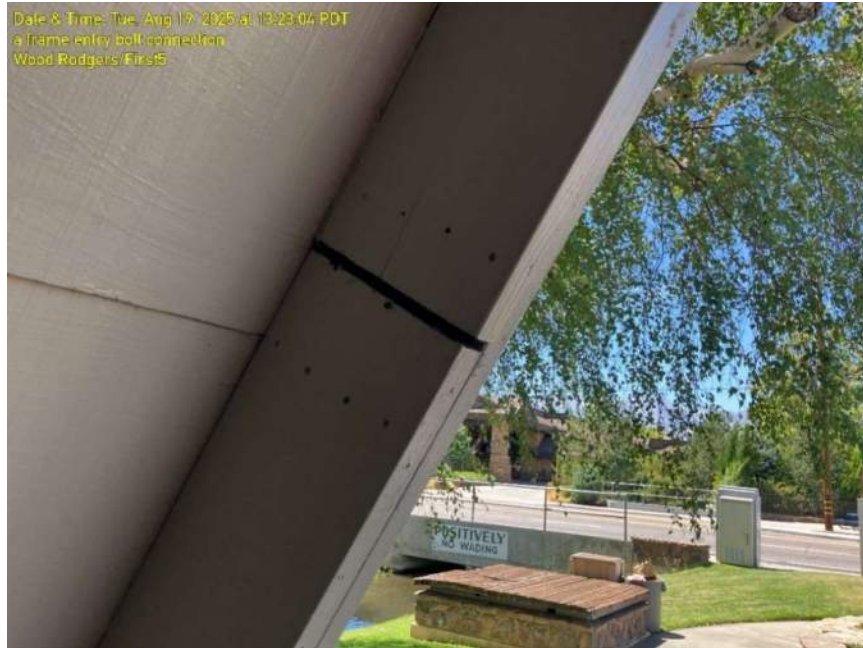
- Of the roof rafters visible, there are seven locations where the existing 2-2x10 roof rafters have been spliced and would not be considered 2-2x10 continuous members. The original structural drawings did not allow splices of the roof rafters within three to four feet of the second-floor height. For examples of the different splice conditions refer to **Photos 2 thru 4**. In **Appendix B**, there is a quantitative study of the load carrying capacity of the existing roof rafters where the rafter splice may be within three feet of second floor. The results of this quantitative study will be addressed in the **Section 4 – Conclusion**.

Photo 2 – At West side roof gable, roof rafter splice with larger separation.

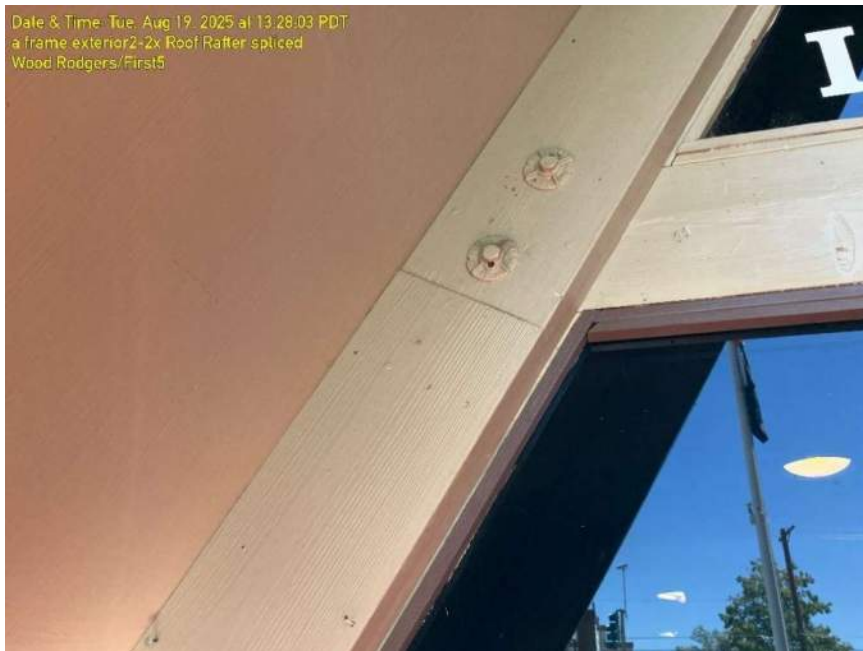
Photo 3 – At West side roof gable, roof rafter splice just below collar tie connection.

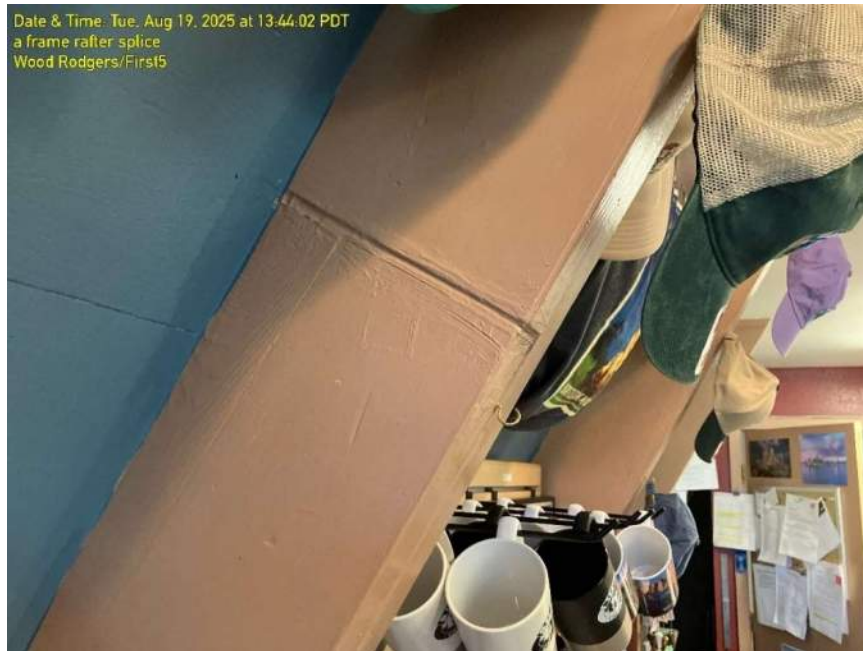
Photo 4 – North side roof at interior rafter splice below collar tie connection.

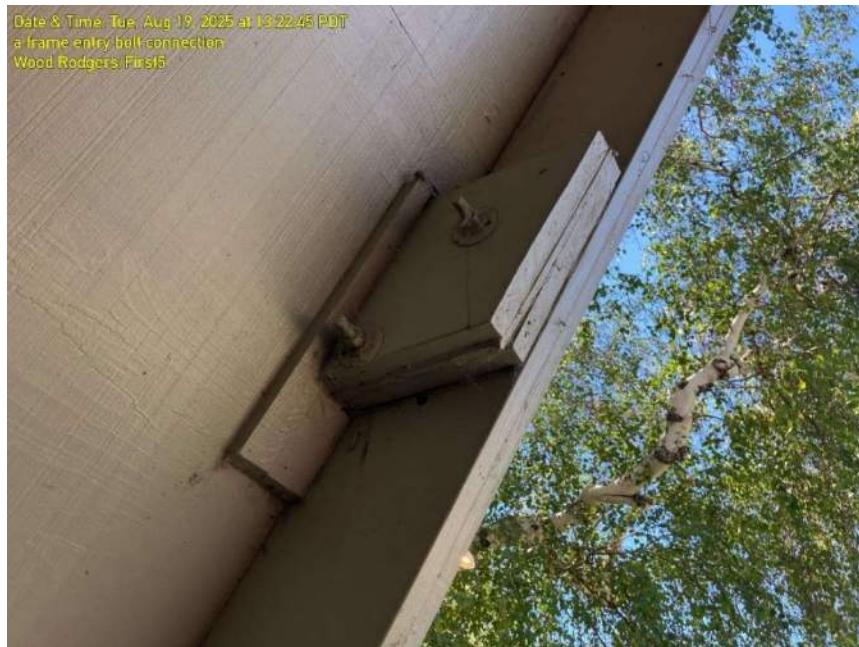
- At the West end gable roof, the roof rafter collar tie member, at the approximate height of the second-floor level, has been removed on the first two roof rafters (refer to **Photos 5 and 6**). In addition, both of these roof rafters contain splices similar to the description of the bullet point above. In **Appendix B**, there is a quantitative study of the load carrying capacity of the existing roof rafters due to the modification of the collar tie and the splice. The results of this quantitative study will be addressed in **Section 4 – Conclusion**.

Photo 5 – Collar tie cut off at gable end roof rafter.

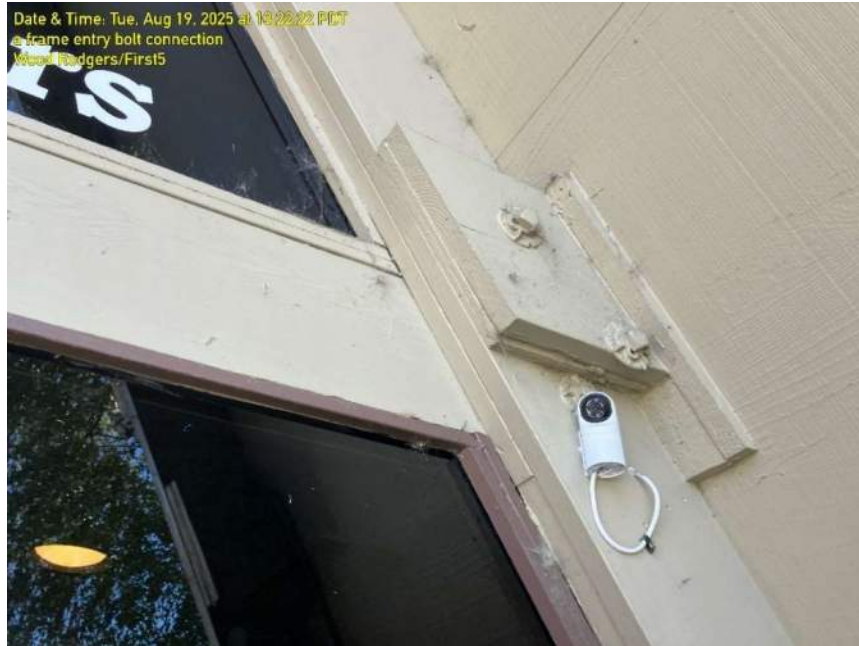
Photo 6 – Collar tie cut off at roof rafter adjacent to the storefront glass.

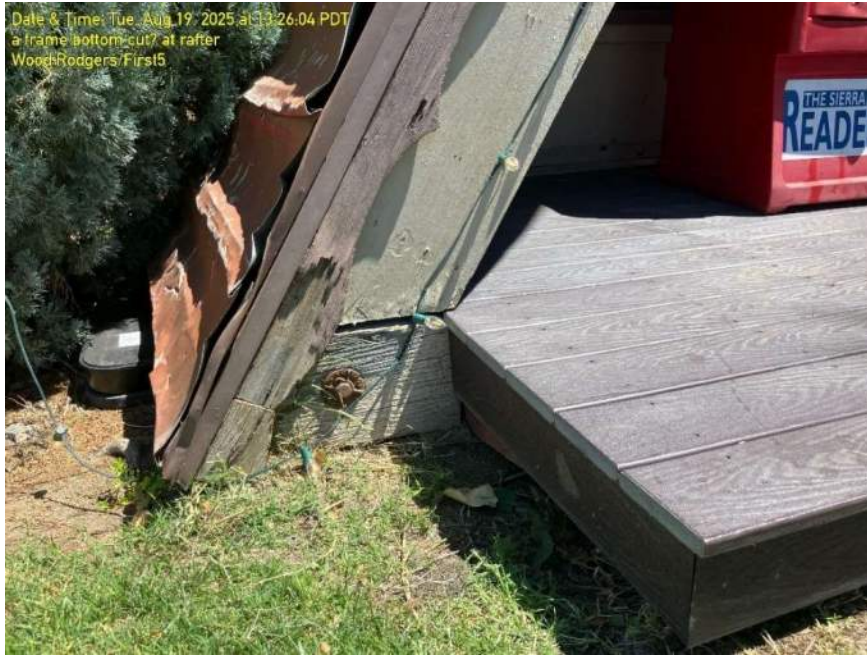
- At the first-floor connection between the roof rafter and the first-floor joist, either the connection has been modified, or the structure was not built to the original drawings. At some locations, the floor joist has been cut at the added wood deck, eliminating the original roof rafter to first-floor tie that forms the A-frame (refer to **Photo 7**). In addition, according to the original drawings, the bolted connection between the rafter and floor was to have a minimum of three (3) bolts. Based on the visible connections, it appears there is only (1) one (refer to **Photo 7 and 8**). This framing condition is considered POOR.

Photo 7 – Northwest corner of first floor to rafter connection, one (1) bolt and floor joist cut.

- The existing bolted connection at the first-floor joist to the roof rafter appears to be a single bolt. The original structural drawings call for a three bolted connection. The single bolt connection could exceed its load carrying capacity.

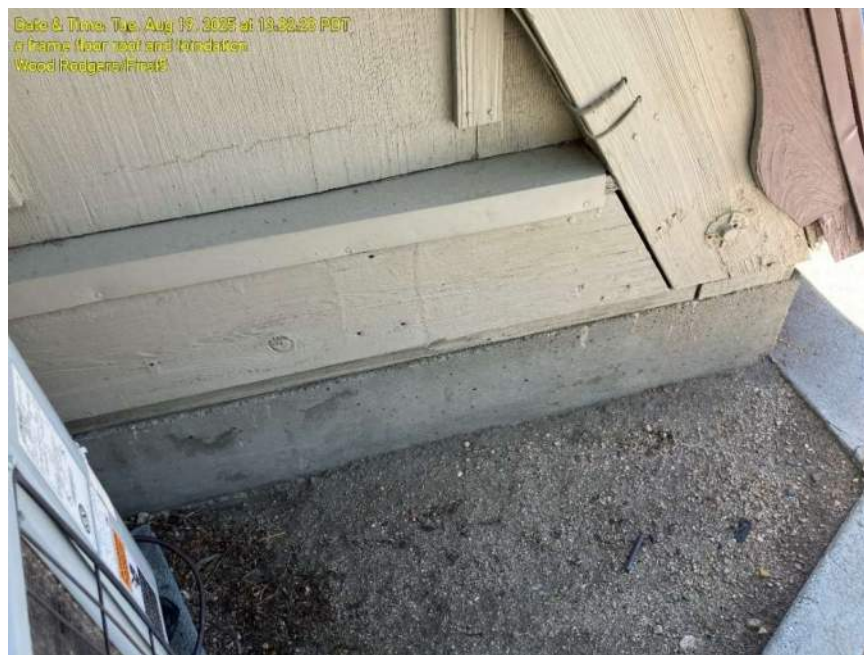
Photo 8 – Northeast corner of first floor to rafter connection, one (1) bolt.

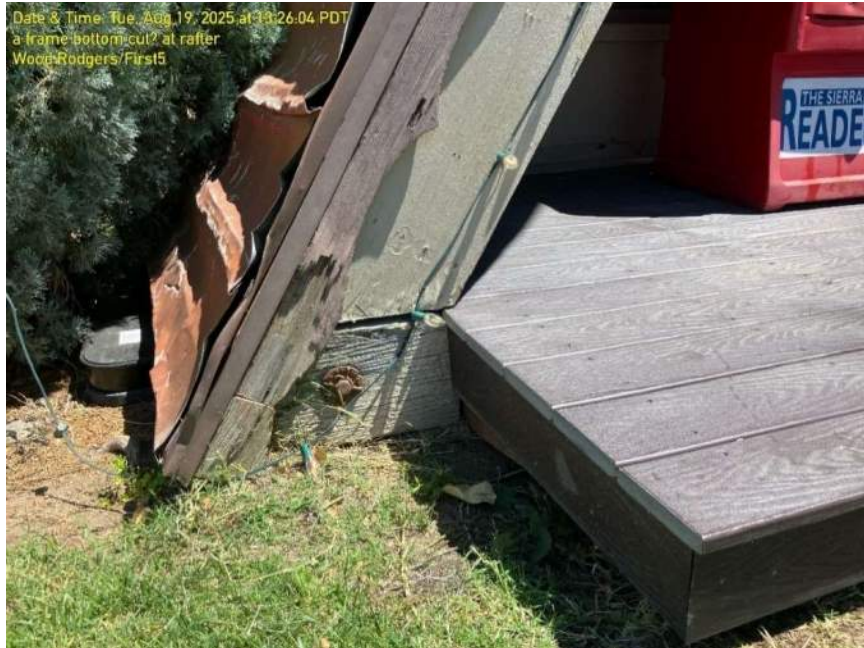
- Around the perimeter of the A-frame building, no visible under-floor venting occurred at the first-floor level (refer to **Photos 9 to 11**). This condition is considered POOR.

Photo 9 – Northwest corner of first floor foundation. No ventilation.

- The first floor does not appear to have any underfloor crawl space ventilation. This potentially has caused or will cause dry rot or other moisture-related damage to the first-floor structural framing.

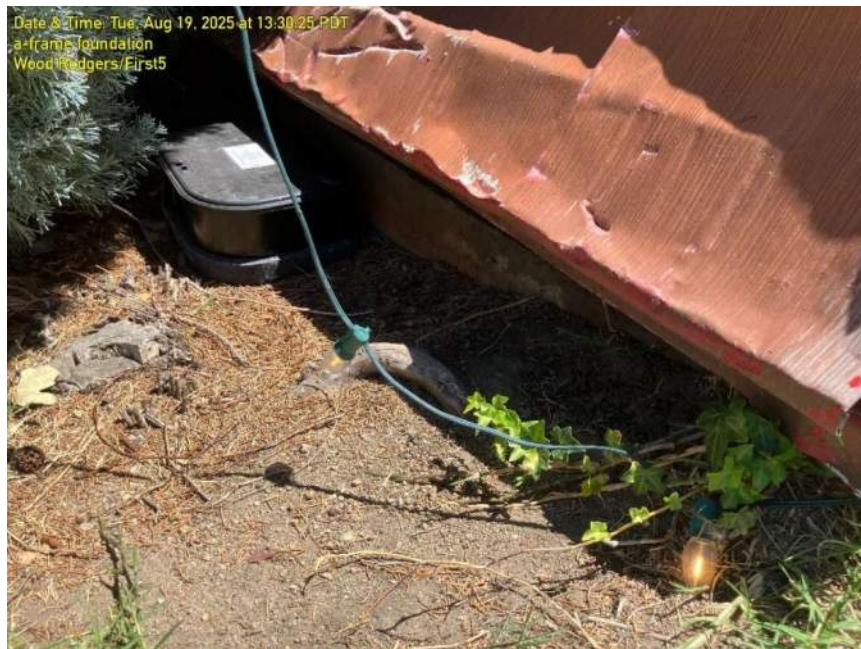
Photo 10 – North Foundation stem wall of first floor foundation. No ventilation.

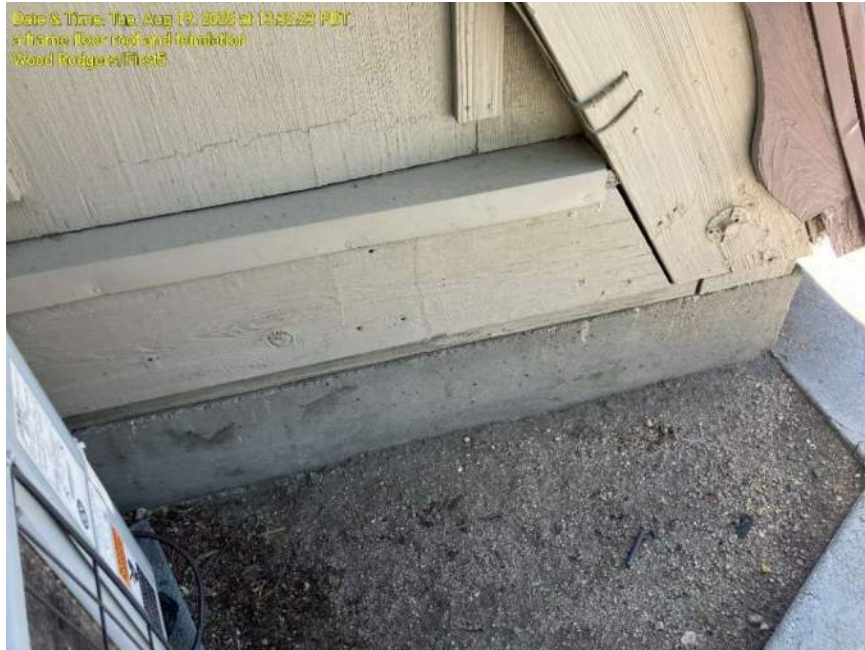
Photo 11 – Northeast corner of first floor foundation. No ventilation.

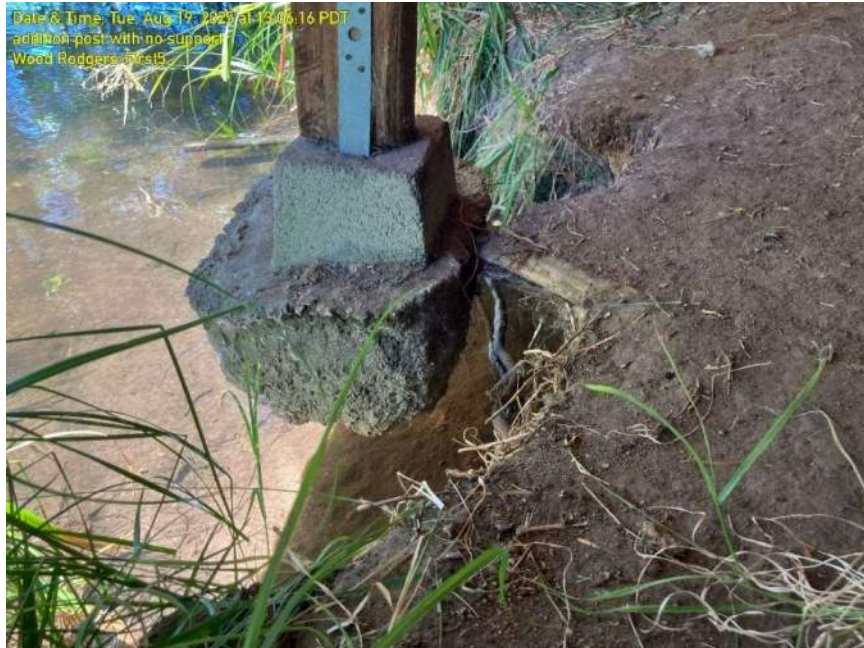
At the southwestern section of the Addition, Creek erosion has undermined the soil beneath the post foundations supporting the floor girder and joists in three distinct locations. As a result, the existing footings no longer provide effective support for the posts (refer to **Photos 12 to 14**). This loss of bearing capacity poses a significant structural concern and is discussed in **Section 4 – Conclusions**.

Photo 12 – Concrete footing undermined by Creek.

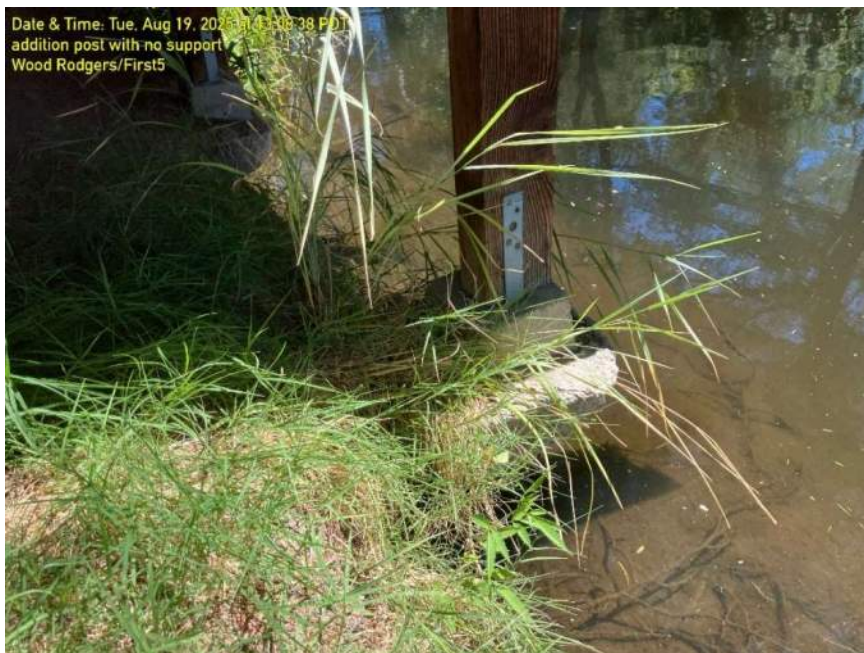
Photo 13 – Soil erosion by Creek under concrete footing

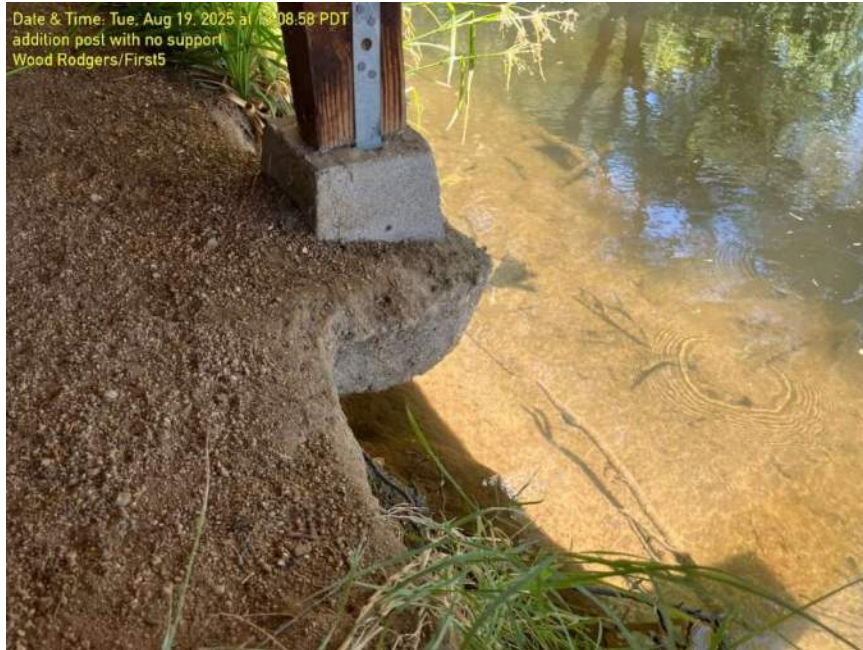
Photo 14 – Soil erosion by Creek under concrete footing

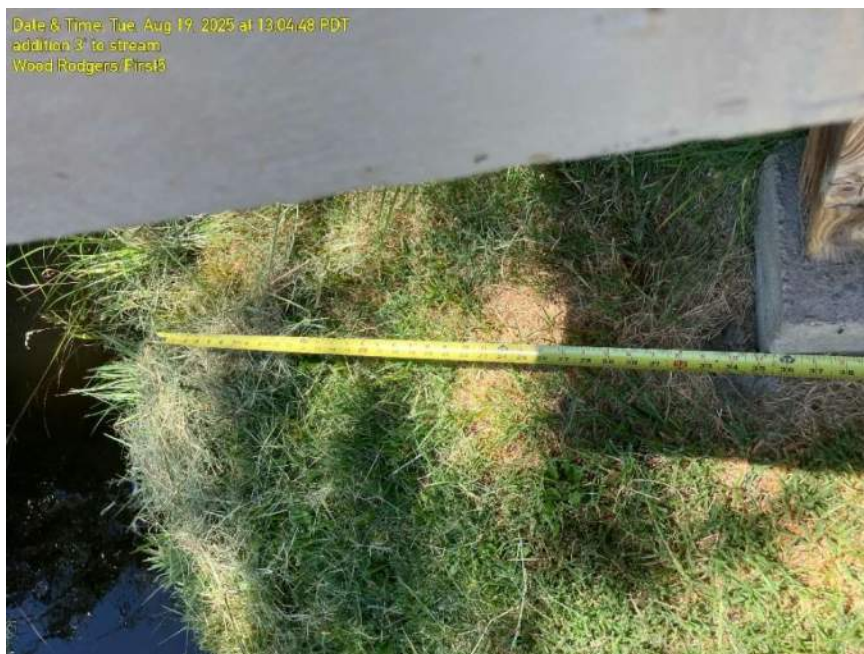
- At the southeastern edge of the Addition, the adjacent Creek flows are eroding the soil, and the embankment is encroaching toward the post foundations. Without mitigation, continued erosion from the Creek will likely compromise the soil supporting these posts, potentially leading to loss of structural support—similar to the condition previously described (see **Photos 15 and 16**). If erosion persists, there is a risk that the Creek flows may eventually undermine the footing beneath the CMU stem wall (refer to **Photo 16**), which could result in significant structural instability. This condition is considered FAIR to POOR

Photo 15 – Creek within three feet of the post foundation.

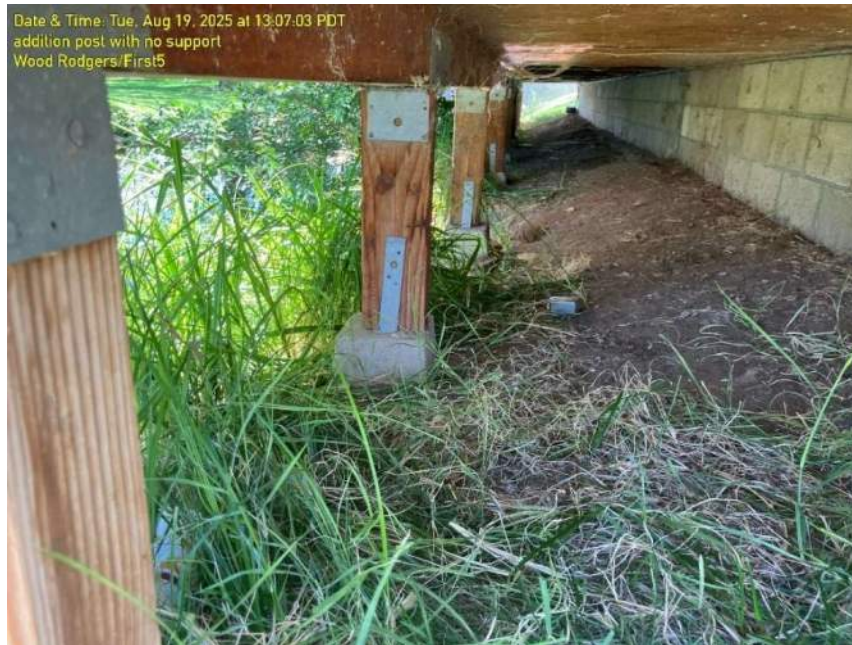
Photo 16 – Creek encroaching on post foundations.

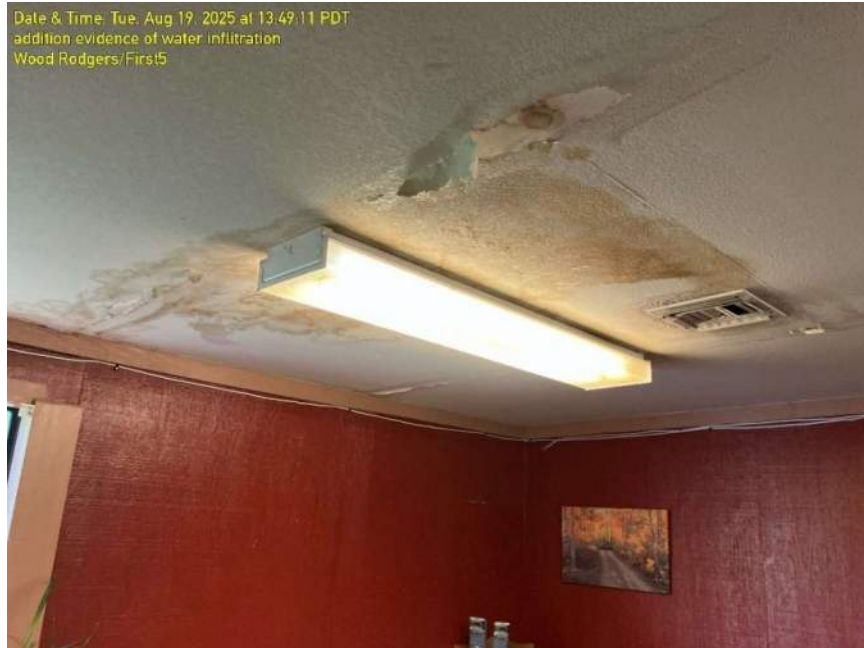
- The existing 6x12 roof joists were only observed at their end connection to the A-frame structure; the remainder of the joists are concealed and not accessible for observation. Notably, staining is visible on the interior sheetrock ceiling, which appears to be the result of past or ongoing roof leaks (see **Photos 17 and 18**). From the rooftop, the slope direction and drainage configuration are unclear (refer to **Photos 19 and 20**), which may be contributing to the potential for water intrusion. Given the suspected leaks and lack of apparent drainage, there is concern that the roof joists may be affected by dry rot or other moisture-related damage. Further evaluation of this condition will be provided in **Section 4 – Conclusion**.

Photo 17 – Visible signs of possible roof leak.

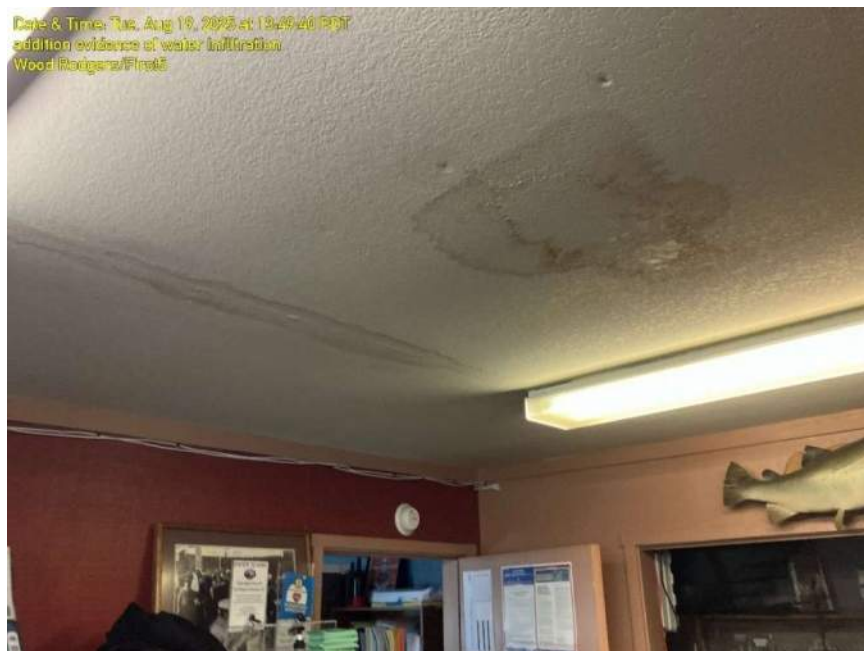
Photo 18 – Visible signs of possible roof leak.

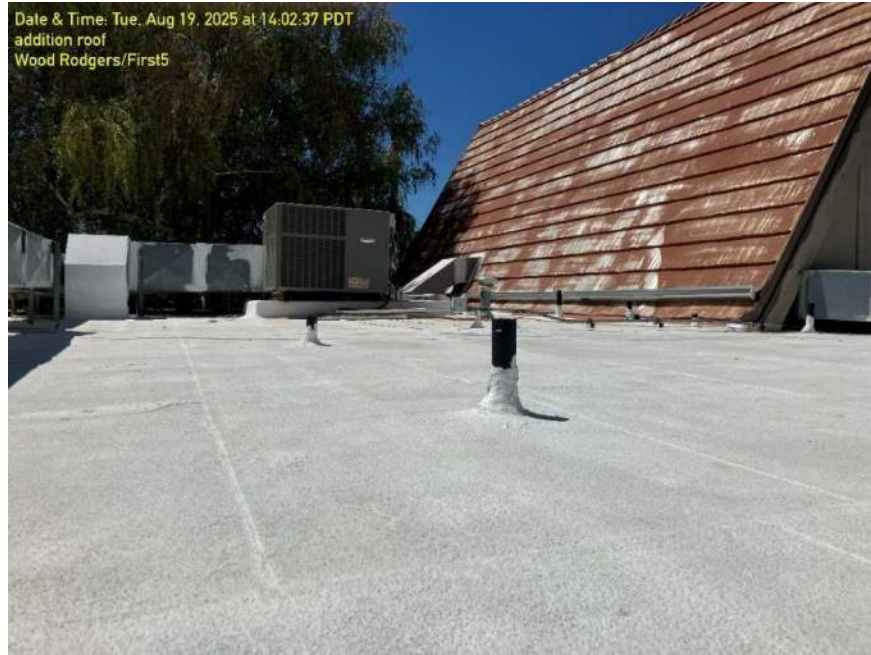
Photo 19 – No apparent roof slope or drainage.

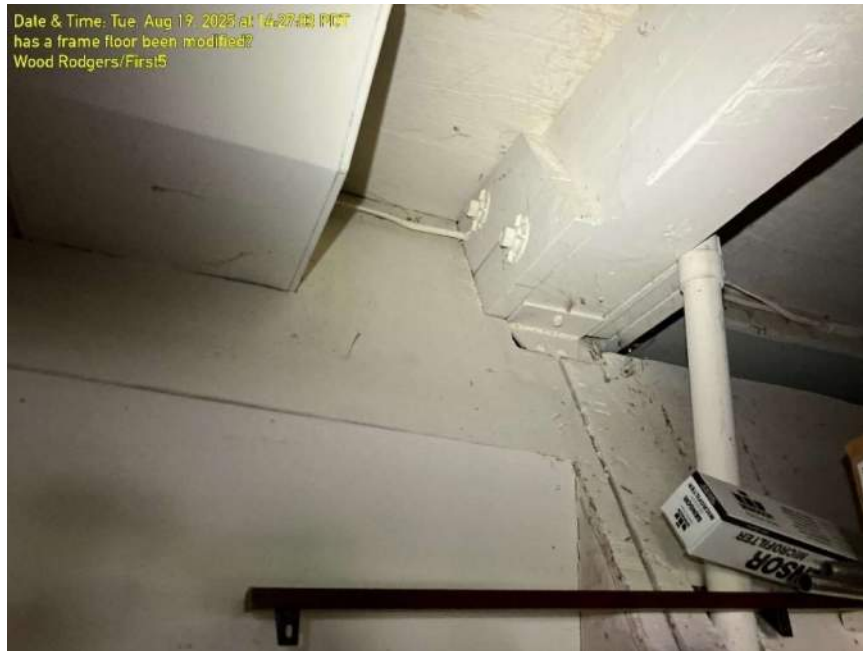
- The existing 6x12 roof joists connect to the existing A-Frame roof joists & floor joists via a bearing seat and bolts (refer to **Photos 20**). The connection of the 6x12 roof joist to the A-Frame is not evident other than the steel bearing seat. There may be additional connectors that are not visible. The original floor joist of the A-Frame would not have extended horizontally past the end of the A-Frame roof rafters. In addition, on one side of the 6x12 roof joists, the existing floor joists would not lap directly to the 6x roof joist due to the difference in widths of the 6x roof joists (5") and double 2x roof rafter (3") [Refer to **Photo 21**]. There may be additional connectors and members that are not visible, but a load path to support members cannot be discerned at this time. This particular connection and support will be addressed in more detail in **Section 4 – Conclusion**.

Photo 20 – 6x12 Roof Joist connection at A-Frame Floor.

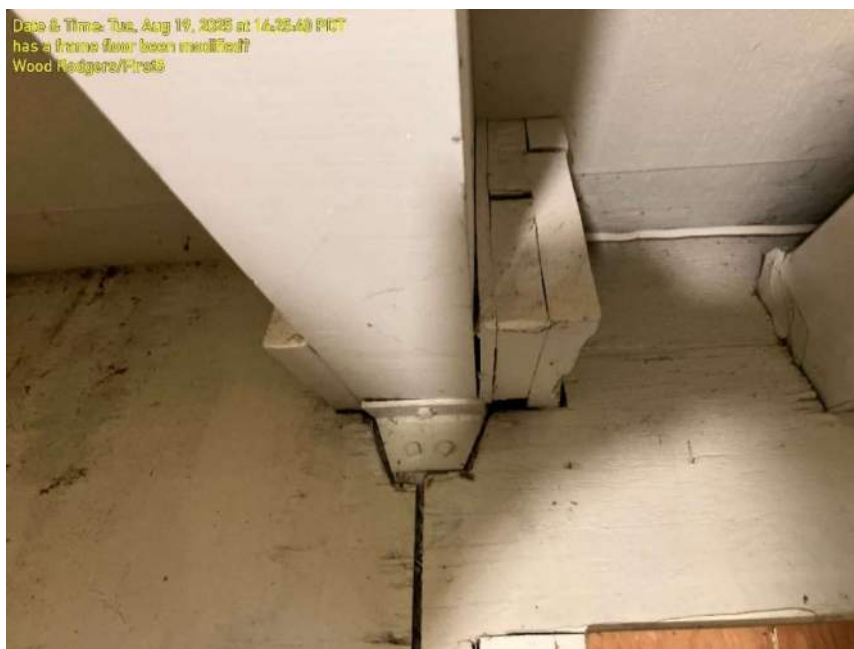
Photo 21 – 6x12 Roof Joist connection at A-Frame Floor showing additional members

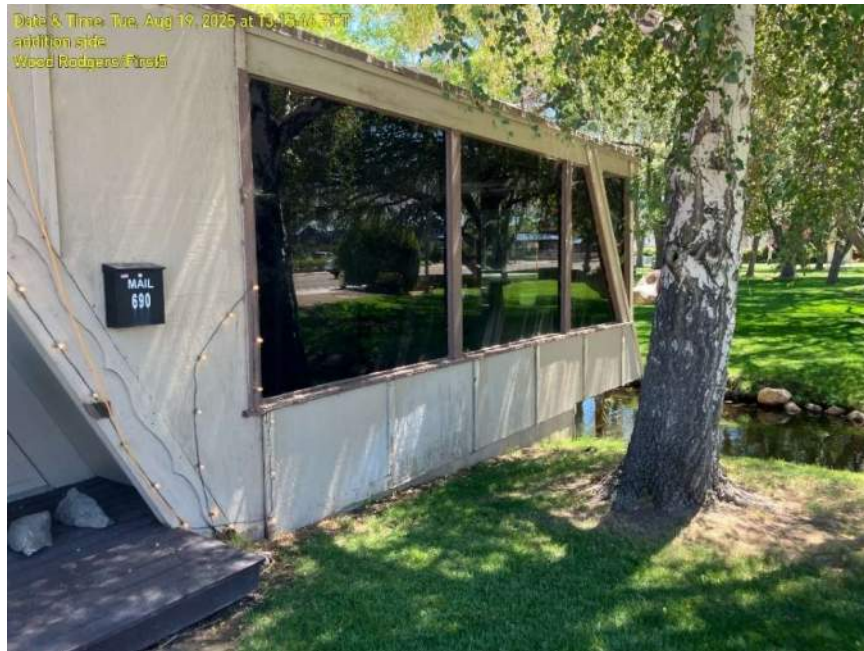
- Around the perimeter of the Addition portion of the Building, no visible under-floor venting occurred at the first-floor level (refer to **Photos 22 to 23**). This condition is considered POOR

Photo 22 – No visible venting of First floor level on West side of Addition

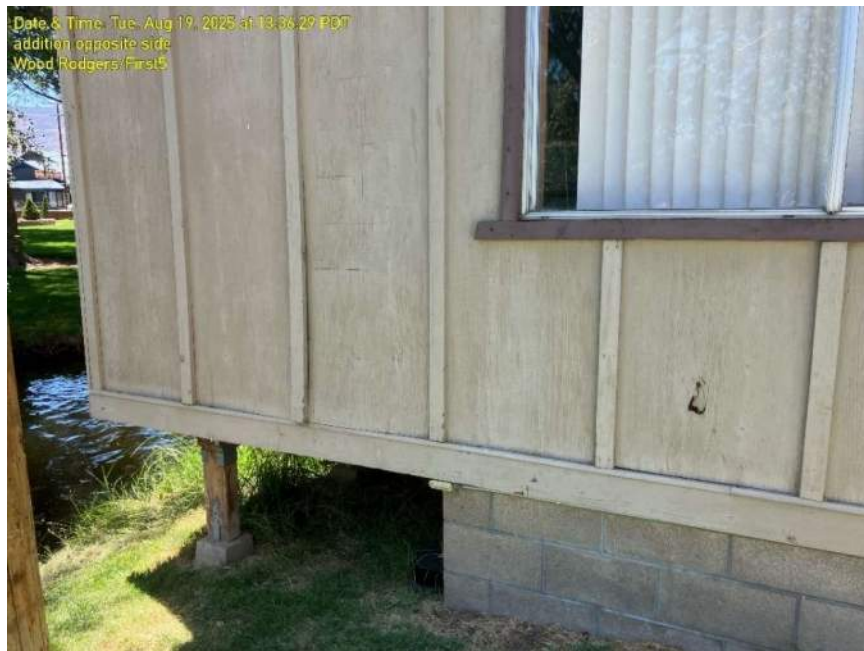
Photo 23 – No visible venting of First floor level on West side of Addition

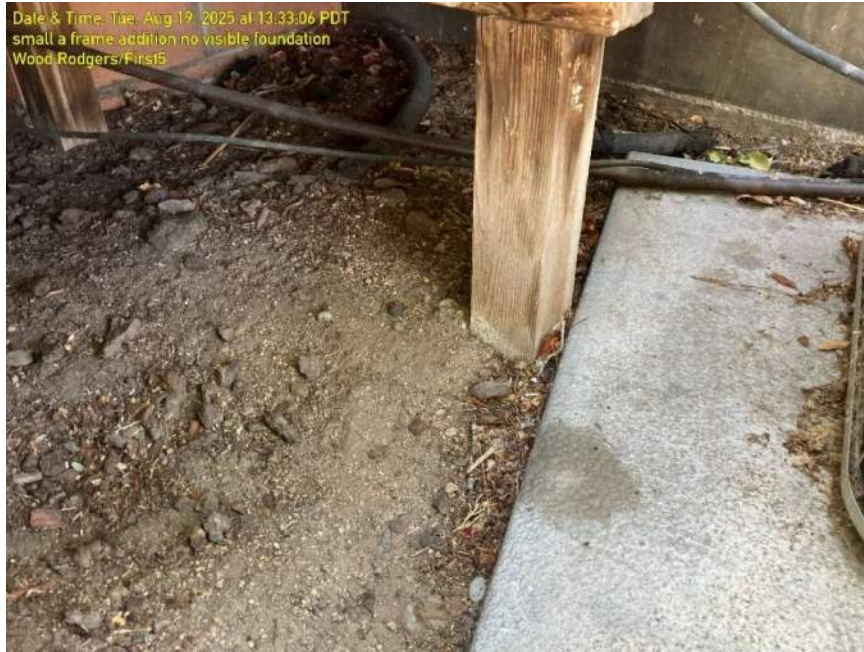
The Small Addition portion that was observed was in FAIR condition. However, there is no apparent concrete foundation supporting the floor girder posts. The posts seem to be either embedded into the soil for support, or the finished soil elevation has been raised resulting in burying the top of the foundation below the current grade. This creates a POOR condition with the posts in contact with soil (Refer to **Photo 24**).

Photo 24 – Showing post in contact with earth and no apparent foundation
